**Assessment of the Underground Distribution System
of the Potomac Electric Power Company**

Final Report

Investigation into Explosions Occurring in or Around the Underground
Distribution System of the Potomac Electric Power Company

Prepared by Stone & Webster Consultants
For the Public Service Commission of the District of Columbia

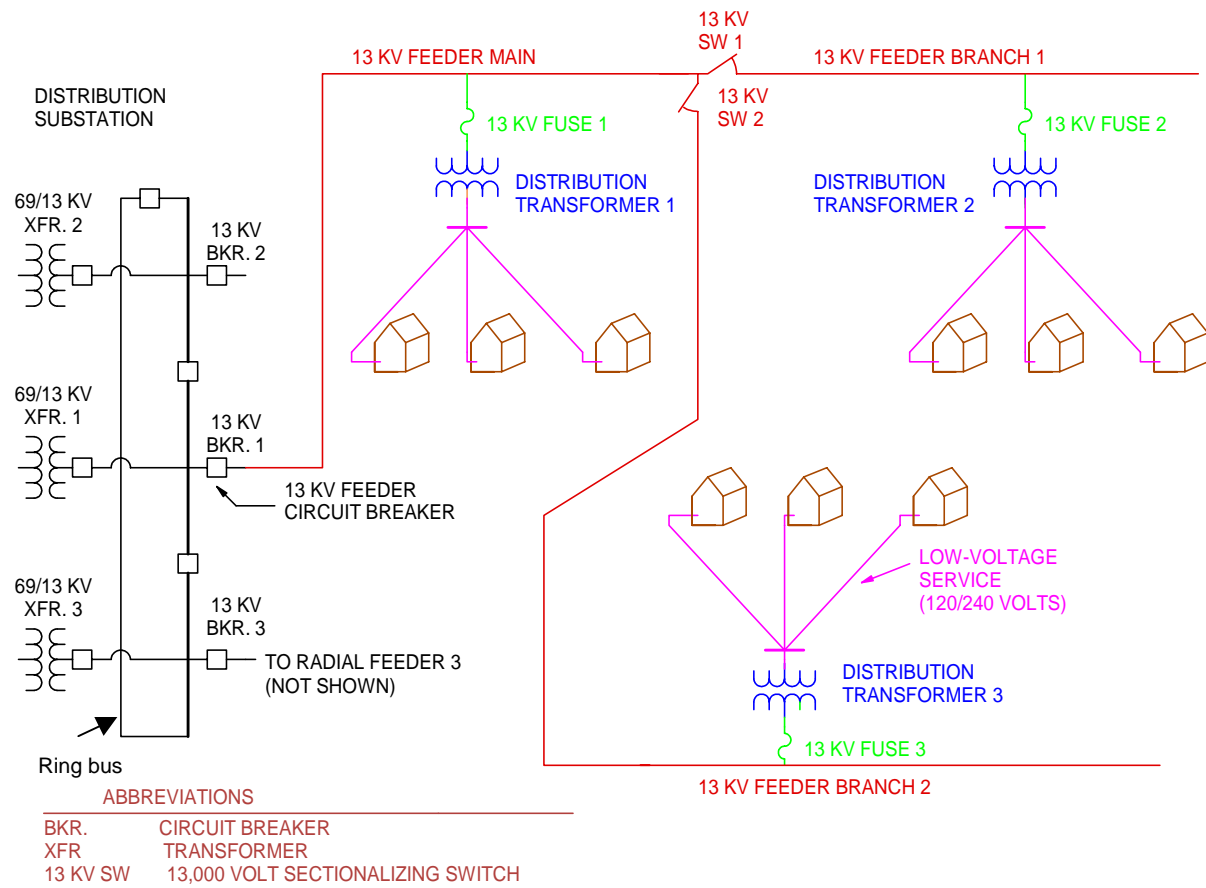
Figure 1 Simplified Radial Primary Distribution System

Figure 1 shows a simplified radial primary distribution system with 13 kV high voltage feeders.

Under normal (unfaulted) conditions in the radial system of Figure 1, the power flow in each component is always away from the distribution substation towards the customer. The topology of the system is similar to that of a tree. The 13 kV feeder main corresponds to the tree's trunk; the 13 kV feeder branches correspond to the tree's branches connected to the tree's trunk; the distribution transformers correspond to second-level branches of the tree; and the low-voltage services correspond to third-level branches of the tree. As long as there are no interruptions in any of the paths of the radial distribution system, power will flow from the distribution substation to all customers fed from the system. This is analogous to nutrients flowing from the earth to the tree's leaves as long as the trunk and none of the branches are completely severed.

If the fault were on 13 kV feeder branch 1 in Figure 1, all customers are without service until the fault is located. After the fault is located, 13 kV switch 1 can be opened to isolate the faulted section of the feeder. Then the 13 kV circuit breaker at the substation is closed to energize the 13 kV main feeder and 13 kV feeder branch 2. This restores electric service to all customers supplied from the transformers connected to these portions of the radial circuit. After the fault is repaired, service can be restored to the customers supplied from 13 kV feeder branch 1 by the closing of 13 kV switch 1.

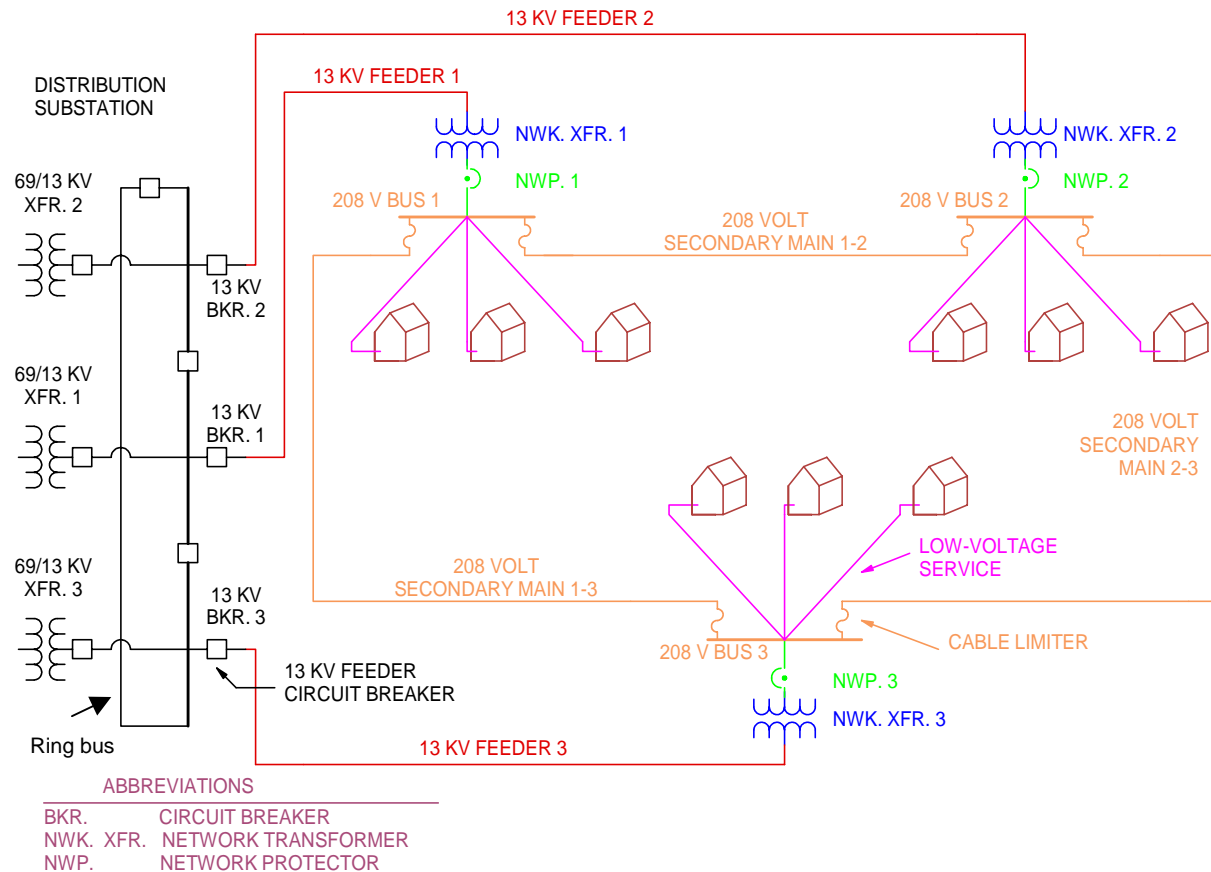
Figure 2 Simplified Low-Voltage Secondary Network System

Note: Only three 13 kV feeders are shown in this simplified low-voltage network system. Each PEPCO low-voltage network is supplied from six 13 kV feeders, with a multiplicity of nwk. xfrs. on each feeder.

Figure 2 shows a simplified low-voltage secondary network system serving the same loads as the radial system in Figure 1. In a network system a short circuit on a 13 kV feeder circuit, in a network transformer, and in a low-voltage secondary main does not cause a loss of power to customers. The reason for this is that there is a multiplicity of paths from the distribution substation to the customers. When any one path is opened, there still are other paths for delivering power from the substation to the customers.

Under normal conditions in the low-voltage network system, the power flow in each 13 kV feeder is from the distribution substation to the network unit (network transformer and protector). In each network unit the power flow is from the network unit to the secondary buses, and along the secondary mains. There is more than one path for the power to flow from the distribution substation to any one customer. The system is protected such that if a short circuit (fault) occurs in any one path, the short circuit is automatically isolated without causing an interruption to the customers served from the network. The system is designed so that with any one 13 kV feeder and its associated network transformers removed from service, the remaining parts of the system can carry the peak load. This is referred to as single-contingency design.

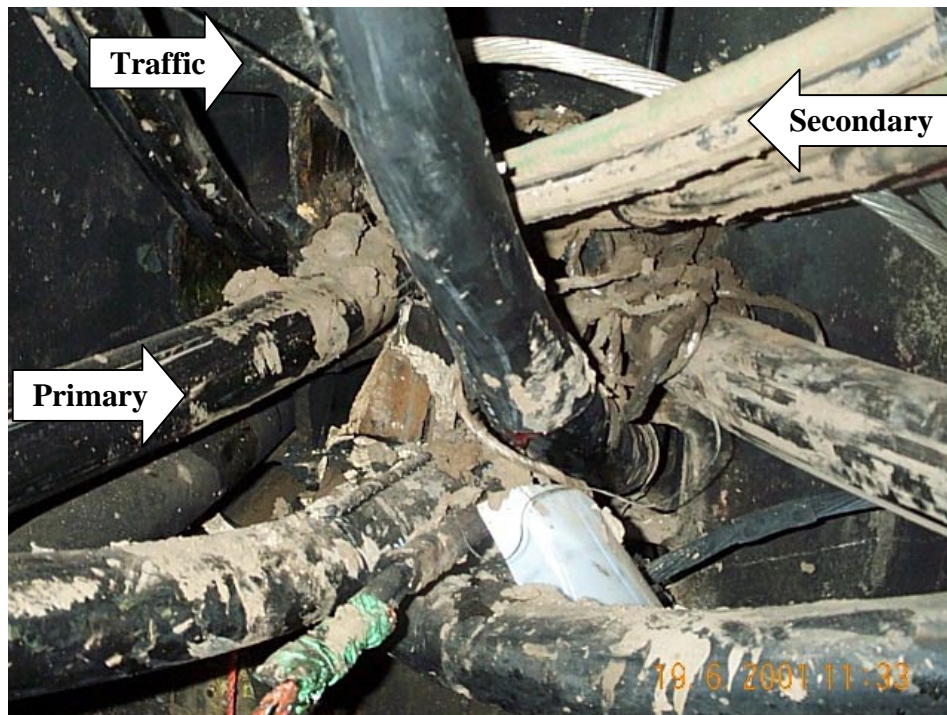
Figure 4 Crowded Manhole within Georgetown with Primary Cables, Secondary Cables, and Traffic Signal or Street Light Cable

Figure 4 shows an example of a crowded manhole in Georgetown. Primary cables, secondary cables, ground (neutral) cables, and either street light or traffic signal wires all come together in one place.

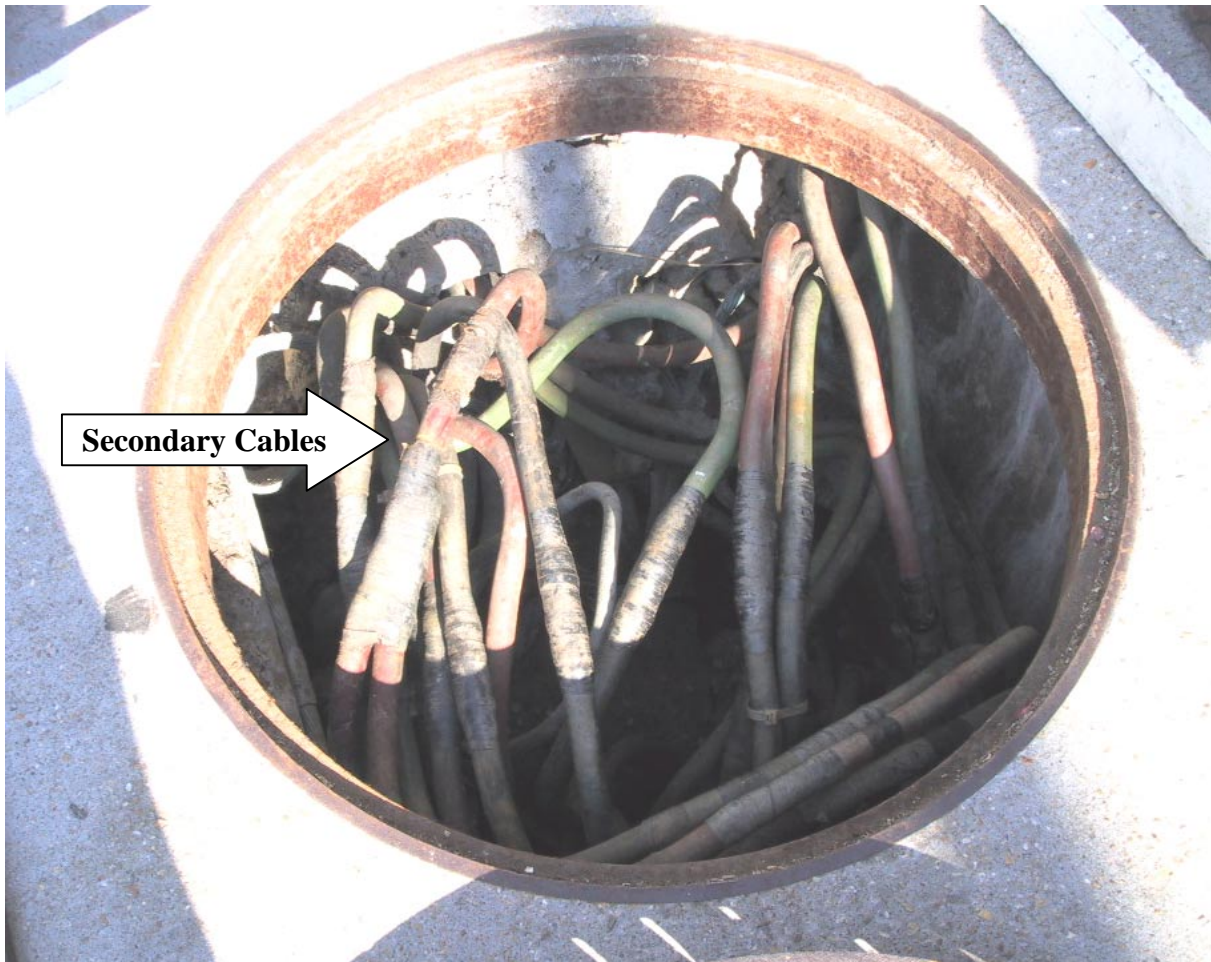
Figure 5 Manhole (Handhole) in Georgetown Crowded with Secondary Cables

Figure 5 shows an example of a crowded hand hole in a sidewalk of Georgetown. Working in a hole like this can be quite difficult because of the lack of space.

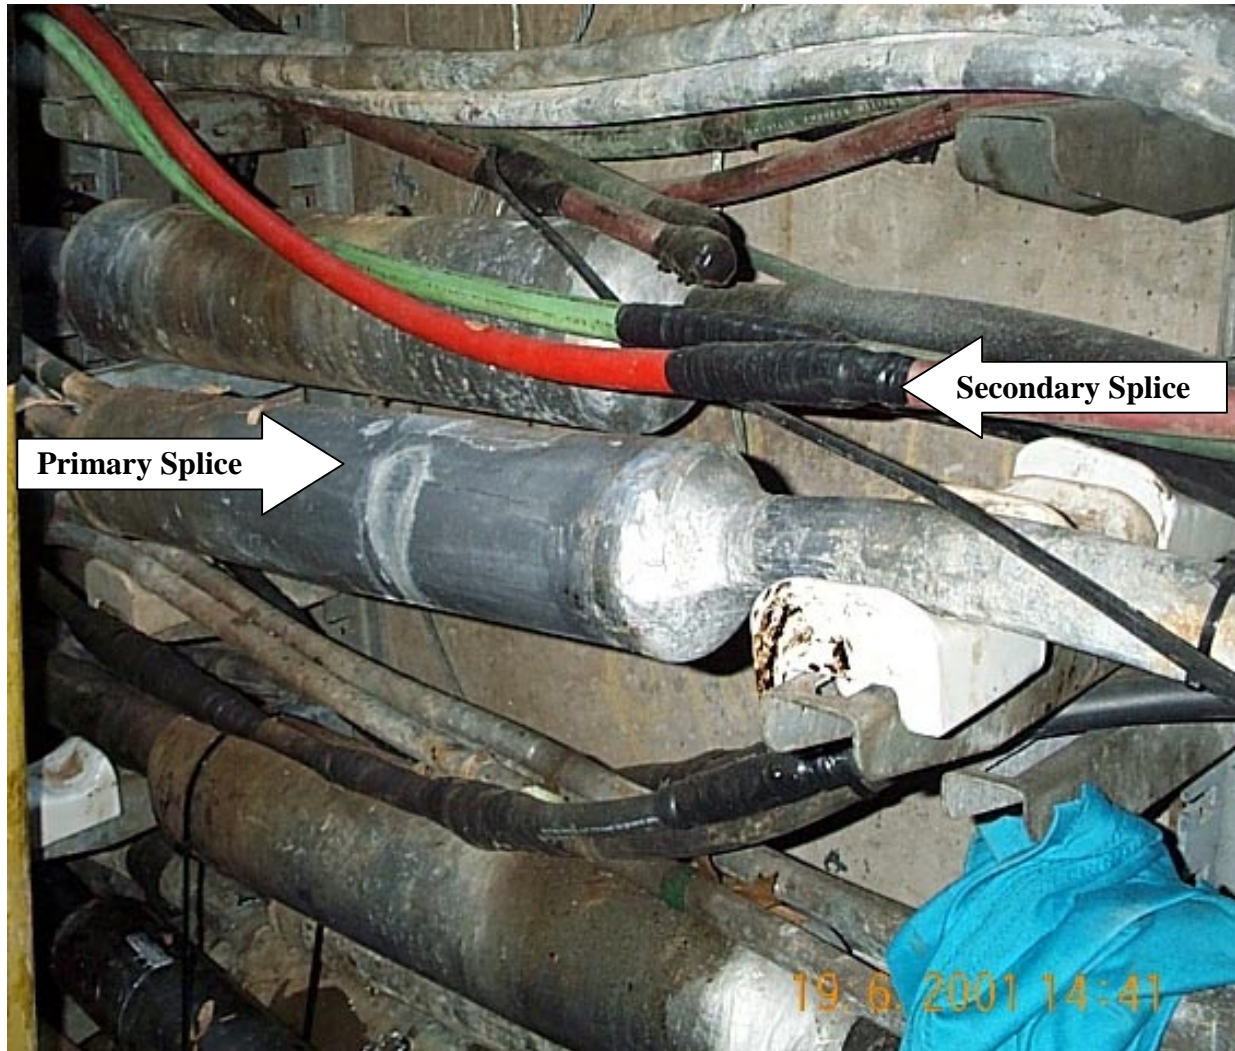
Figure 6 Crowded Manhole in Georgetown with Primary and Secondary Cables in Very Close Proximity

Many manholes in Georgetown contain both primary and secondary cables, with close spacing between primary and secondary cables as illustrated in Figure 6. At this location secondary cables are adjacent to primary cable splices. Should the primary cable splice fail, it is likely to affect the secondary cables.

Due to lack of physical space in Georgetown manholes, the primary was not always below the secondary cables, nor were the secondary cables on an opposite wall from the primary cables. Separation between primary and secondary cables is desirable to reduce the probability of a fault originating in a secondary cable from affecting a primary cable (and vice versa), as happened in Georgetown in the June 13-16, 2001 event.

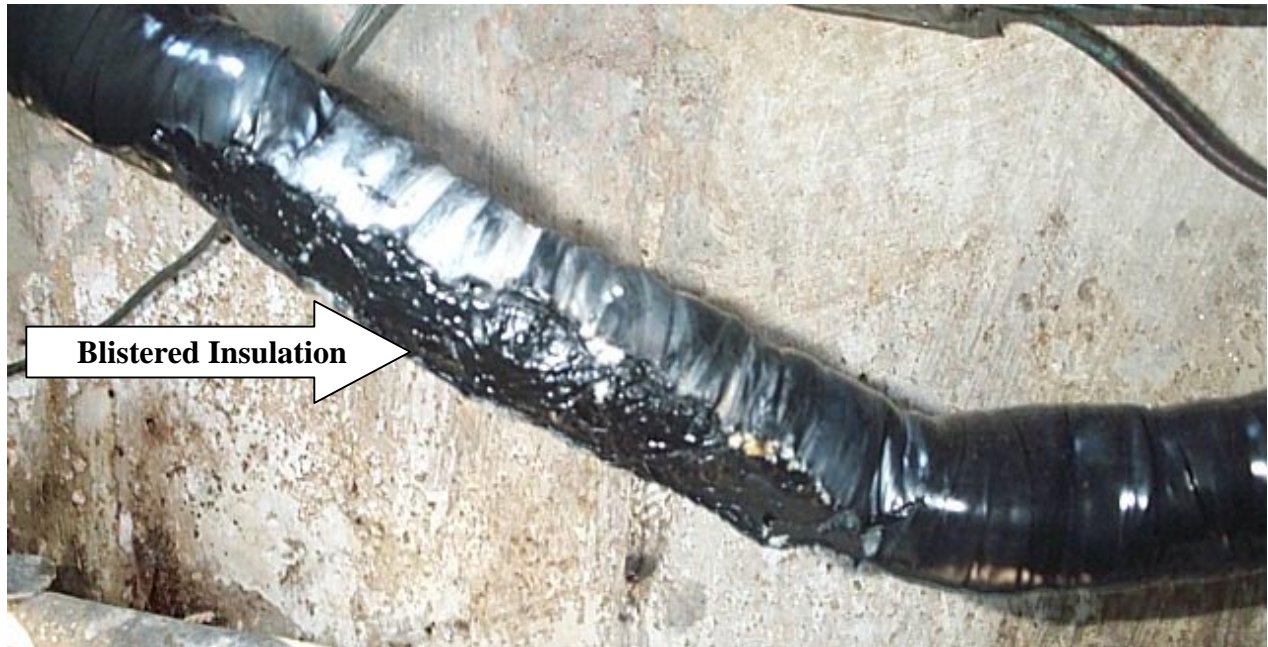
Figure 7 Hot (290° F) Secondary Splice Located During Field Inspection

A hot (290° F versus the design maximum of 167° F) 208-volt splice was found at the corner of N and 35th Streets in the Georgetown secondary network system (Figure 7). Bubbling and blistering of the insulation are visible in the picture. The hot splice was called in and repaired by a responding crew. During the repair, the crew found and replaced another splice with deteriorating insulation. This small, crowded manhole contained both 4kV primary and 208-volt secondary cables, and is an example of a situation where a primary fault could propagate into a secondary fault and vice versa.

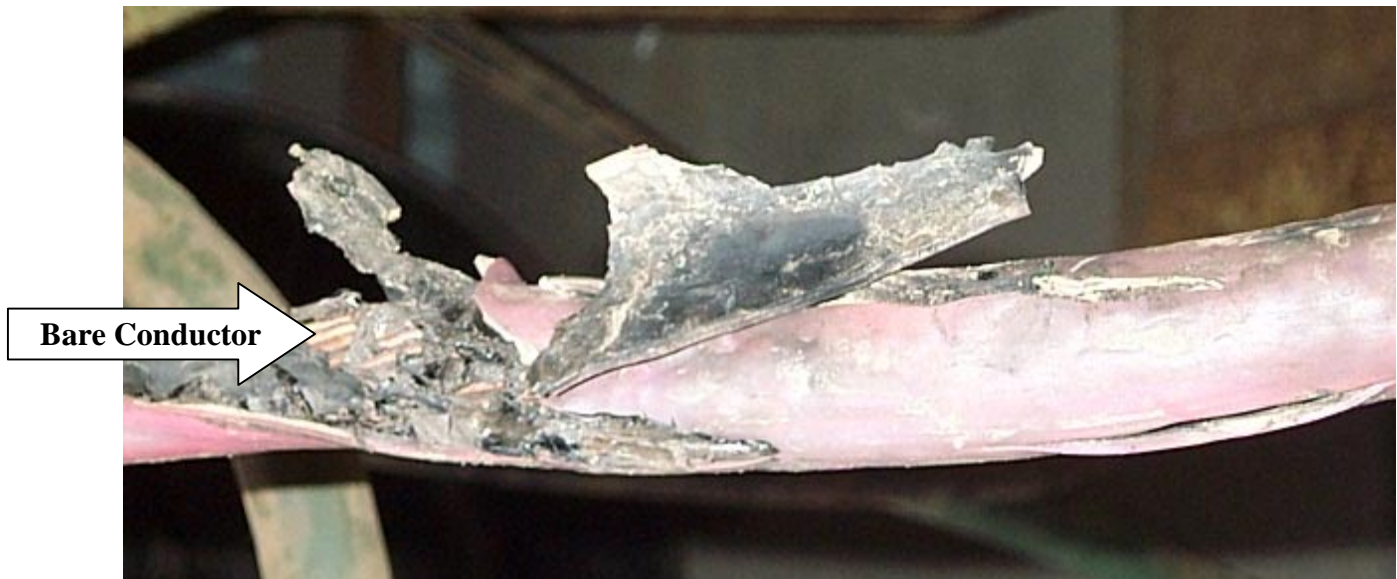
Figure 8 Overheated Secondary Cable Removed from Georgetown after a Manhole Incident

Figure 8 shows a section of secondary cable removed during repair of failures in Georgetown. The sample was selected from a large bin of failed cable stored in a warehouse at the Benning Service Center. Visual inspection of the cable's insulation reveals overheating. However, since there is no indication of fire damage, the insulation was most likely overheated due to excessive electric current.

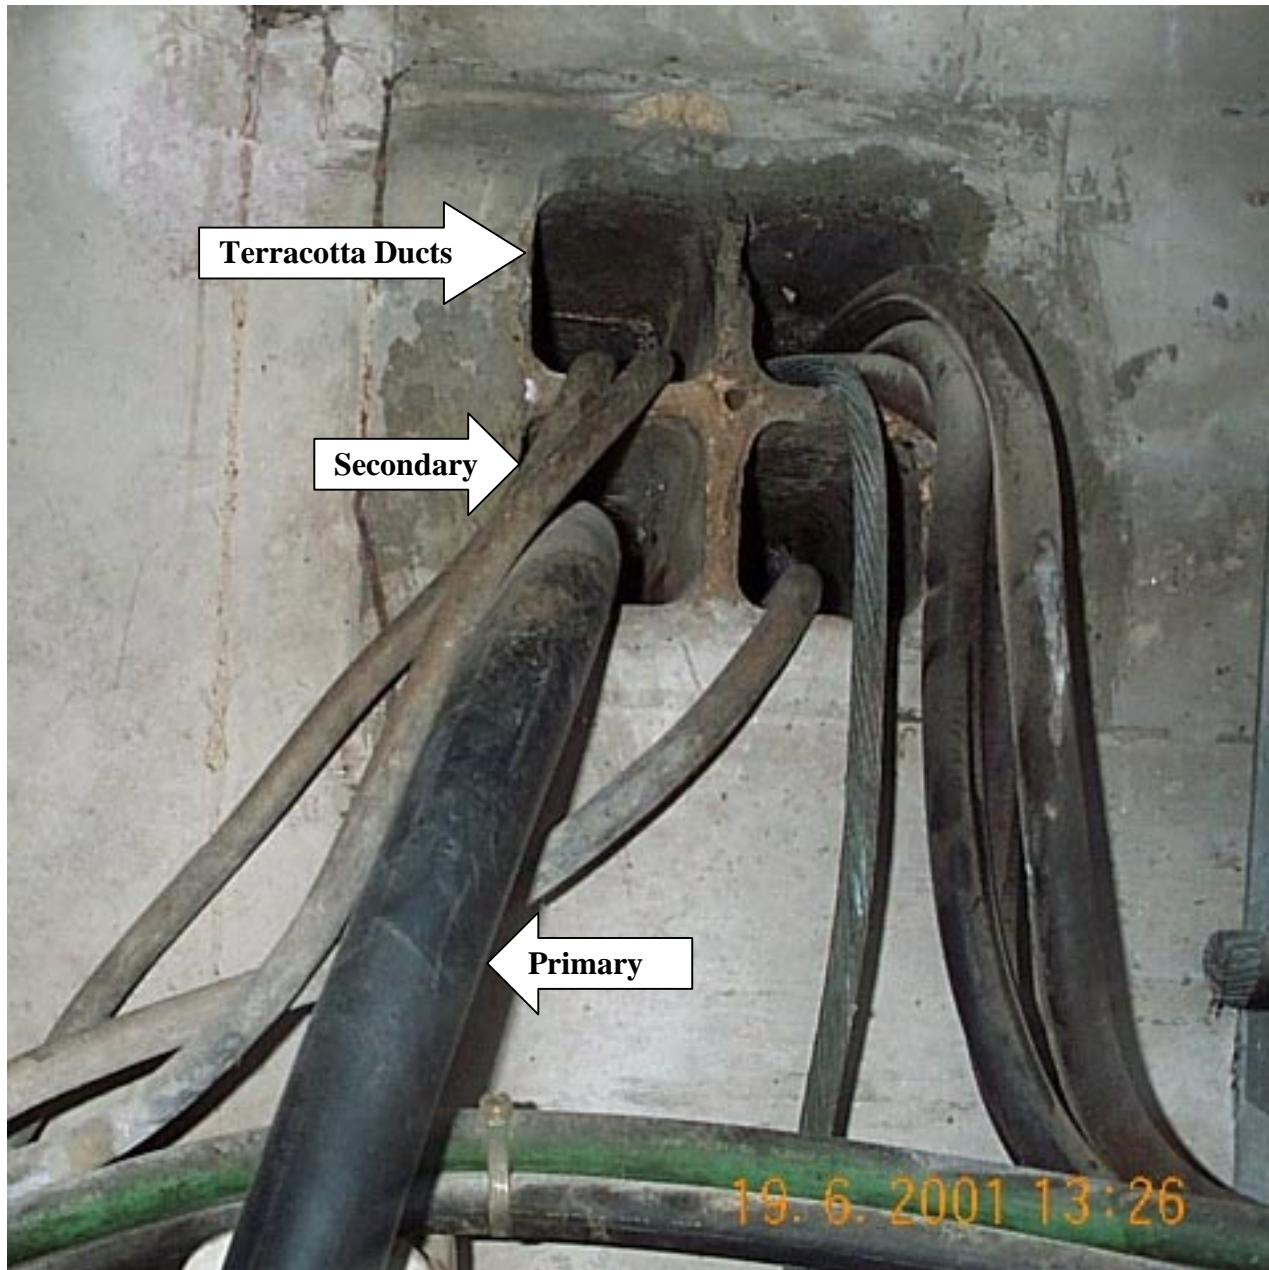
Figure 9 Terracotta Ducts with Primary and Secondary Cables within a Duct Bank

An example of the use of old-style material in Georgetown manholes is terracotta ductwork, shown in Figure 9. In this example, the terracotta tiles form four square duct holes arranged in an overall square. Different numbers of ducts of different cross-section areas are found in different manholes. Although terracotta is a durable material, it is brittle and the joints between tiles can separate, effectively blocking the duct.

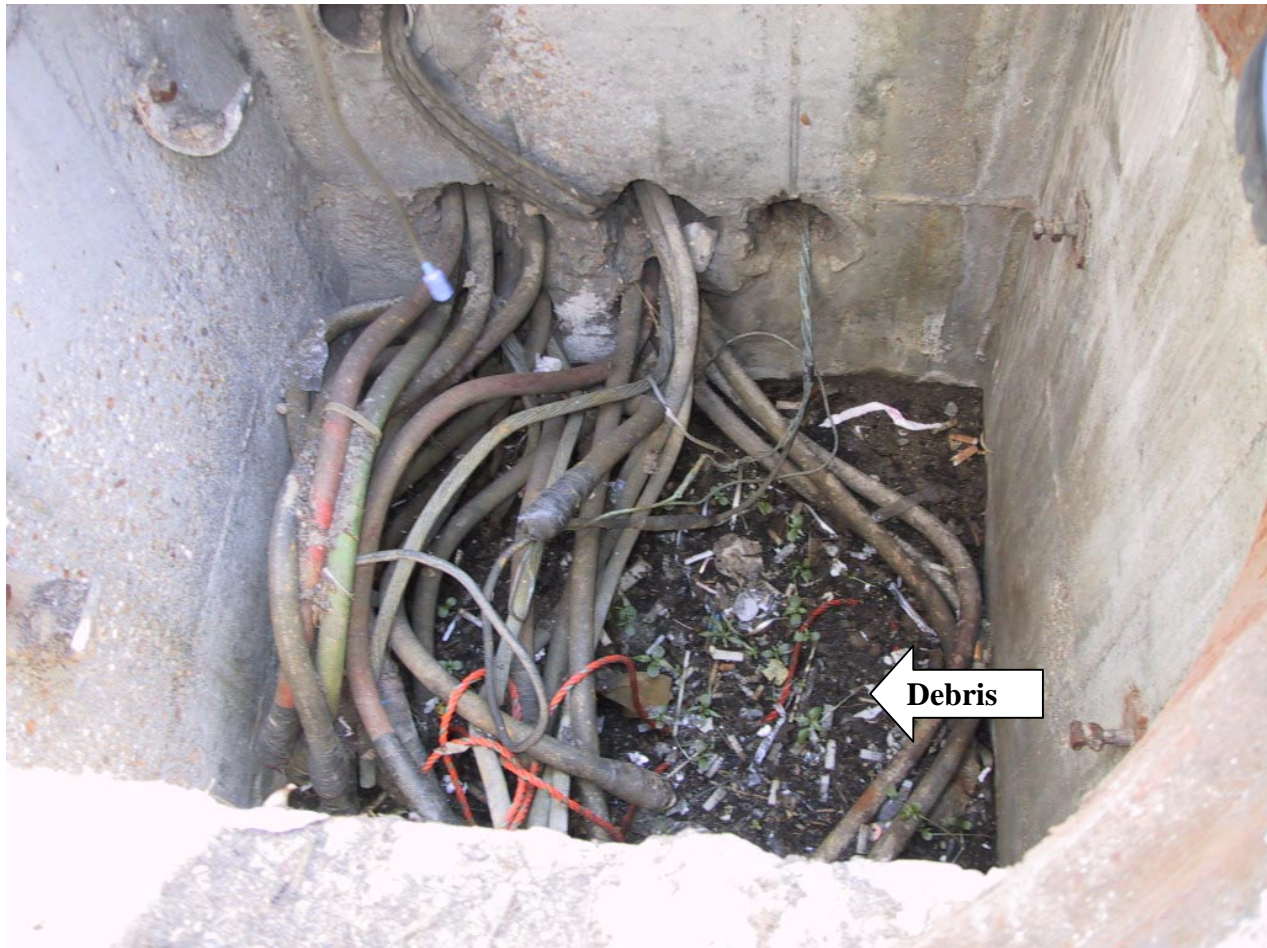
Figure 11 Debris Inside a Manhole With a Slotted Cover

Concern has been expressed about the accumulation of debris in manholes with slotted covers. This concern is justified, as debris was found on the floors of some manholes with slotted covers. Figure 11 shows an example of debris accumulation on the manhole floor. Another example of debris accumulation was observed in a manhole on 33rd Street near Q Street, which had a layer of leaves on the manhole floor.

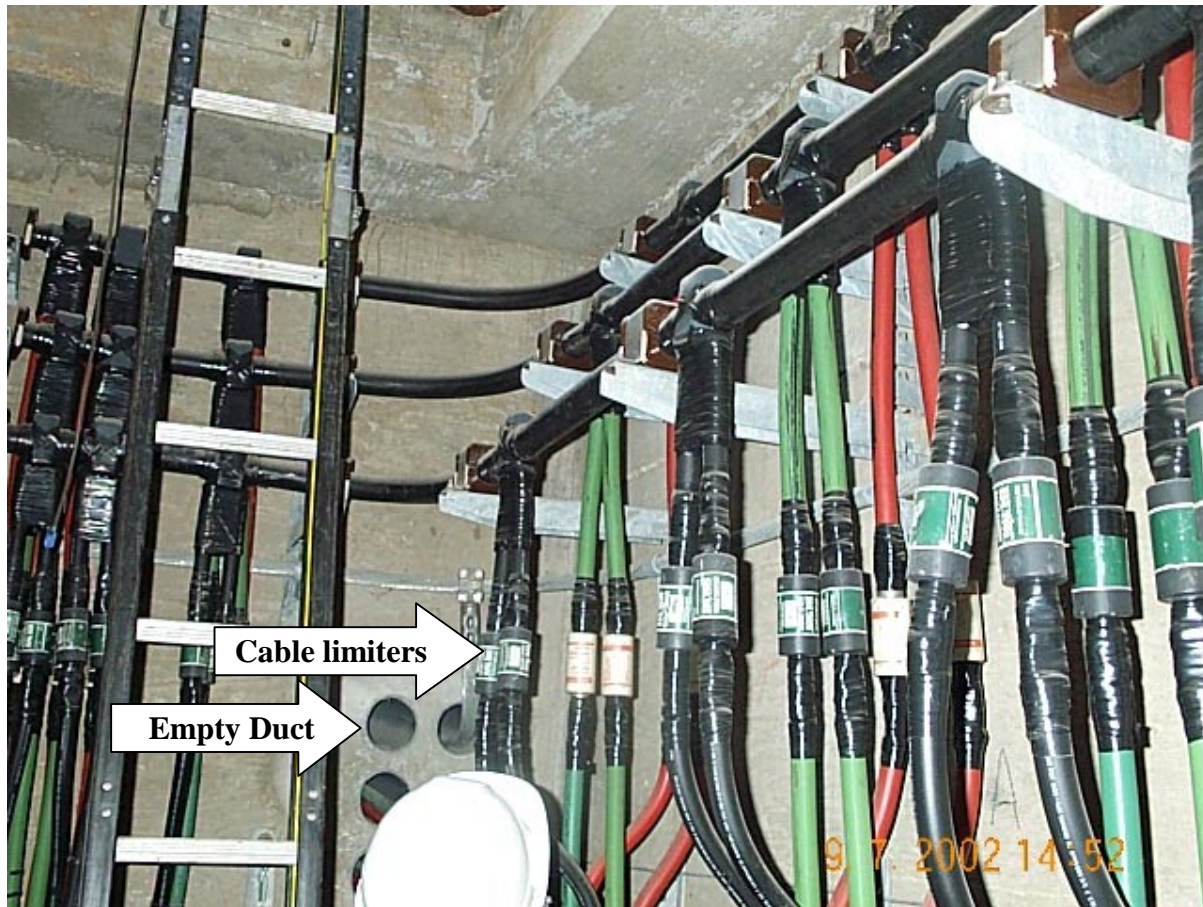
Figure 13 Secondary Bus Hole Showing Quality Workmanship

As in Georgetown, a generally high quality of workmanship was observed. Figure 13 shows an example of high quality workmanship in a secondary bus hole. Note the cable limiters installed on the secondary cables and empty ducts available for future expansion.

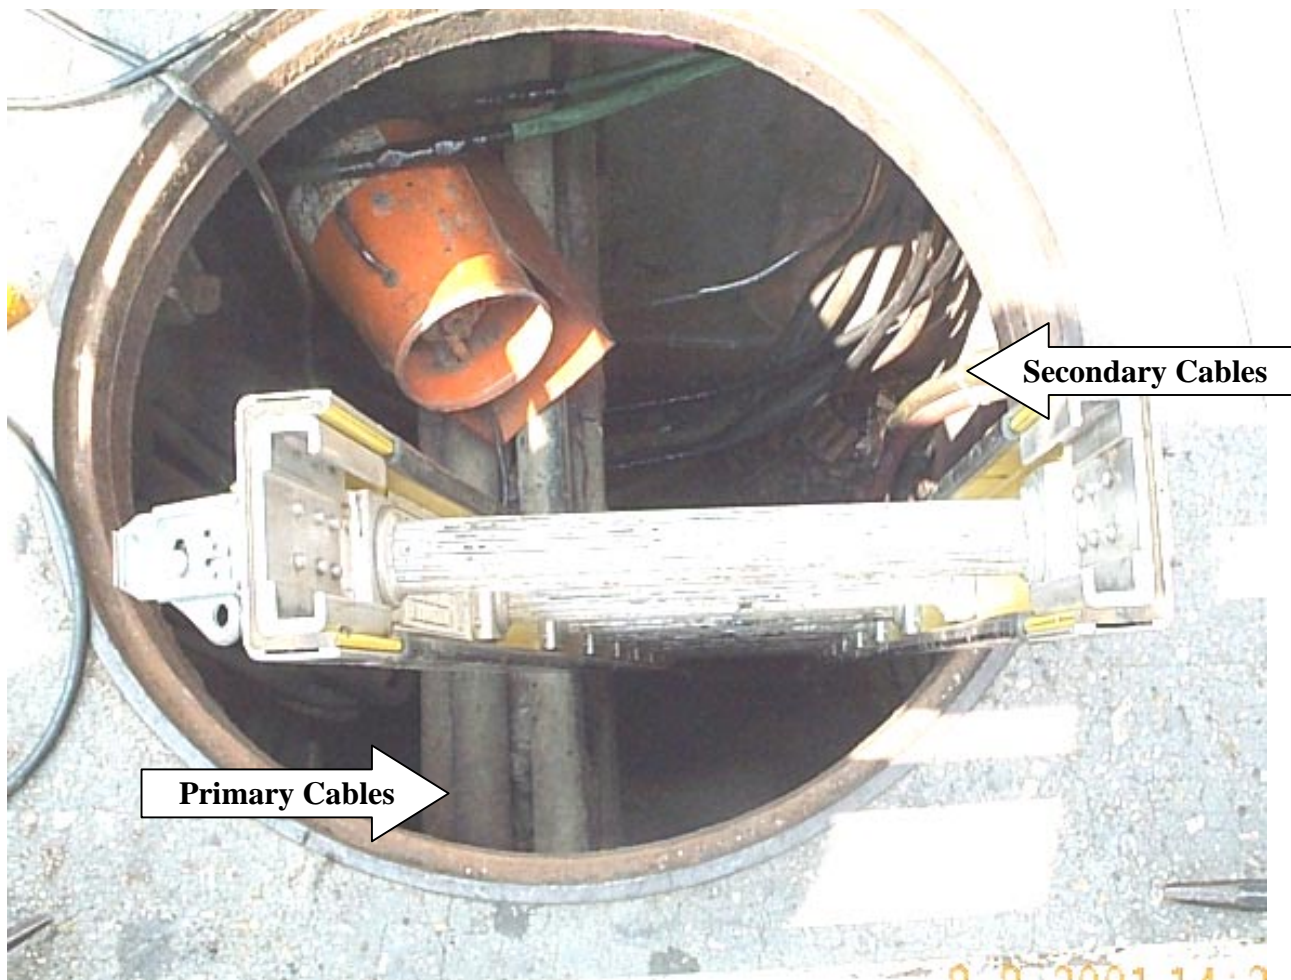
Figure 14 Crowded Adams Morgan Manhole

Figure 14 shows an Adams Morgan manhole while the work was in progress. The present need for additional cables further raises a concern regarding the future capacity of the underground system in Adams Morgan. This needs to be resolved by network modeling and analytical prediction of cable loading for present and future years.

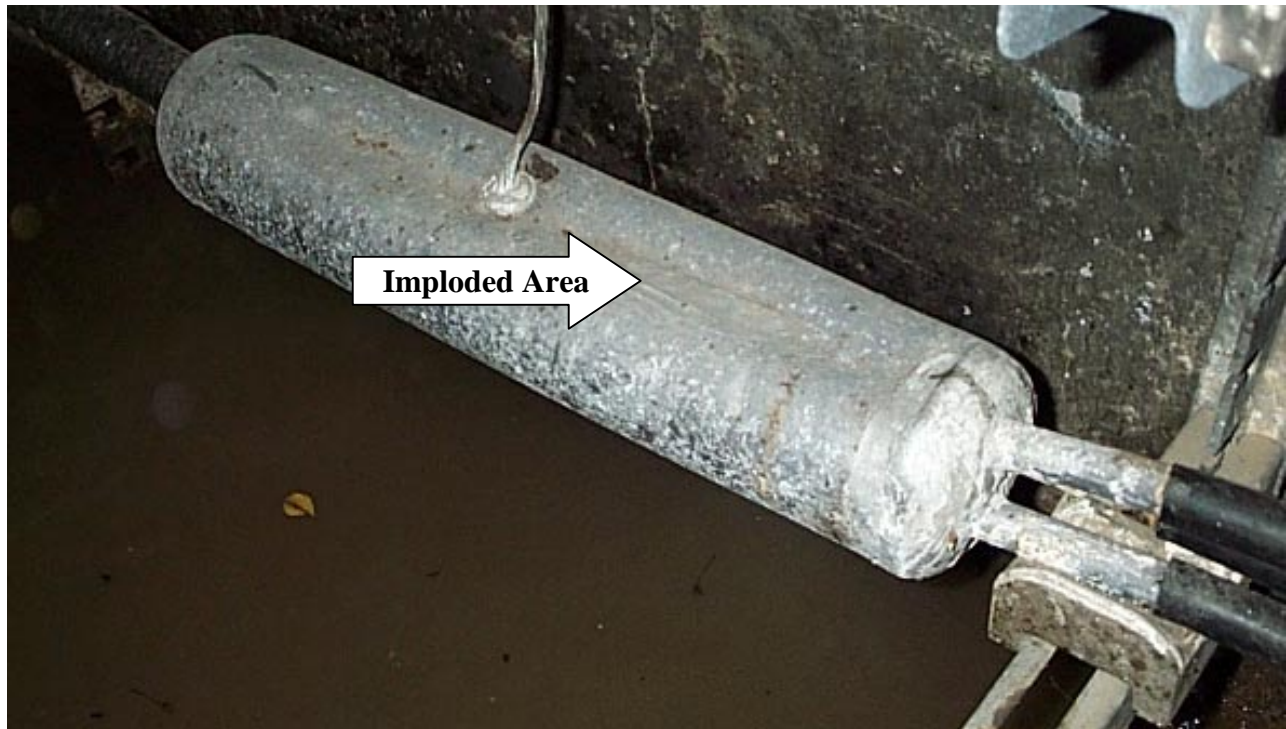
Figure 16 Imploded Primary PILC Y-Splice

Deficiencies were observed in some of the manholes. For example, two slightly imploded primary cable lead splices were found. When a lead cable is spliced, the splice is filled with a tar-like compound. If insufficiently filled, the lead will partially collapse over time. Figure 16 shows an imploded splice. The lead covering the splice should be cylindrical. In this case, the upper surface of the outside lead is indented, appearing like a groove on the top of the splice. While not an immediate concern for failure, imploded splices should be replaced to prevent premature failure. This is an example of the kind of condition the Pepco manhole inspection program is designed to detect and repair.

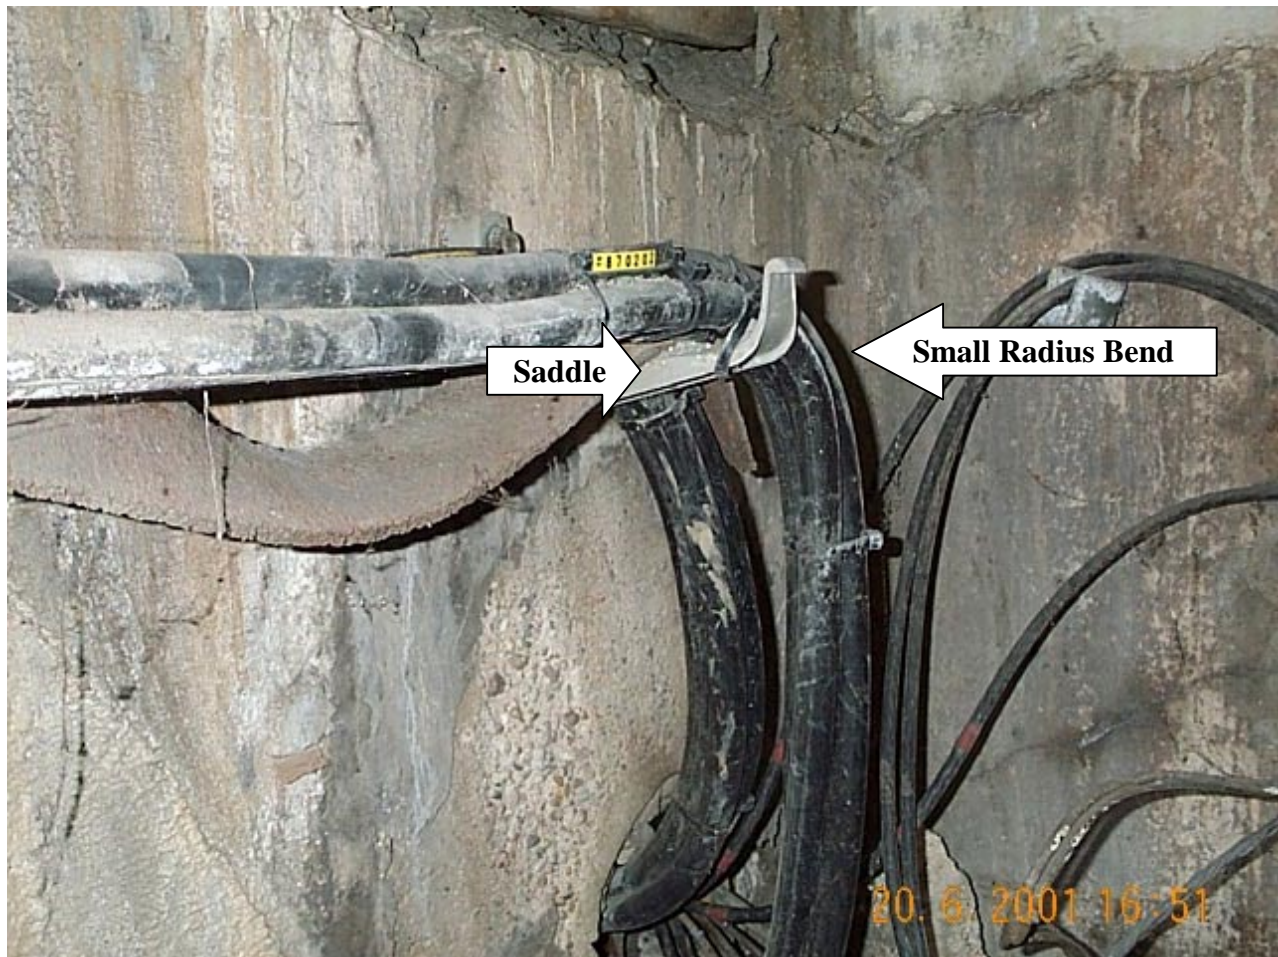
Figure 17 Primary Cables with Small Radius Bend and Missing Porcelain in the Saddle

While workmanship is generally very good, problems do exist in manholes anywhere. For example, Figure 17 shows some additional problems observed in a manhole. The primary cable has a small tight bending radius that can lead to problems as the cable heats and cools over its load cycle. Also, the porcelain saddle the cable should rest on is missing. Sliding of the cable over the metal bracket can result in wear on the jacket and possible ingress of moisture and subsequent failure.

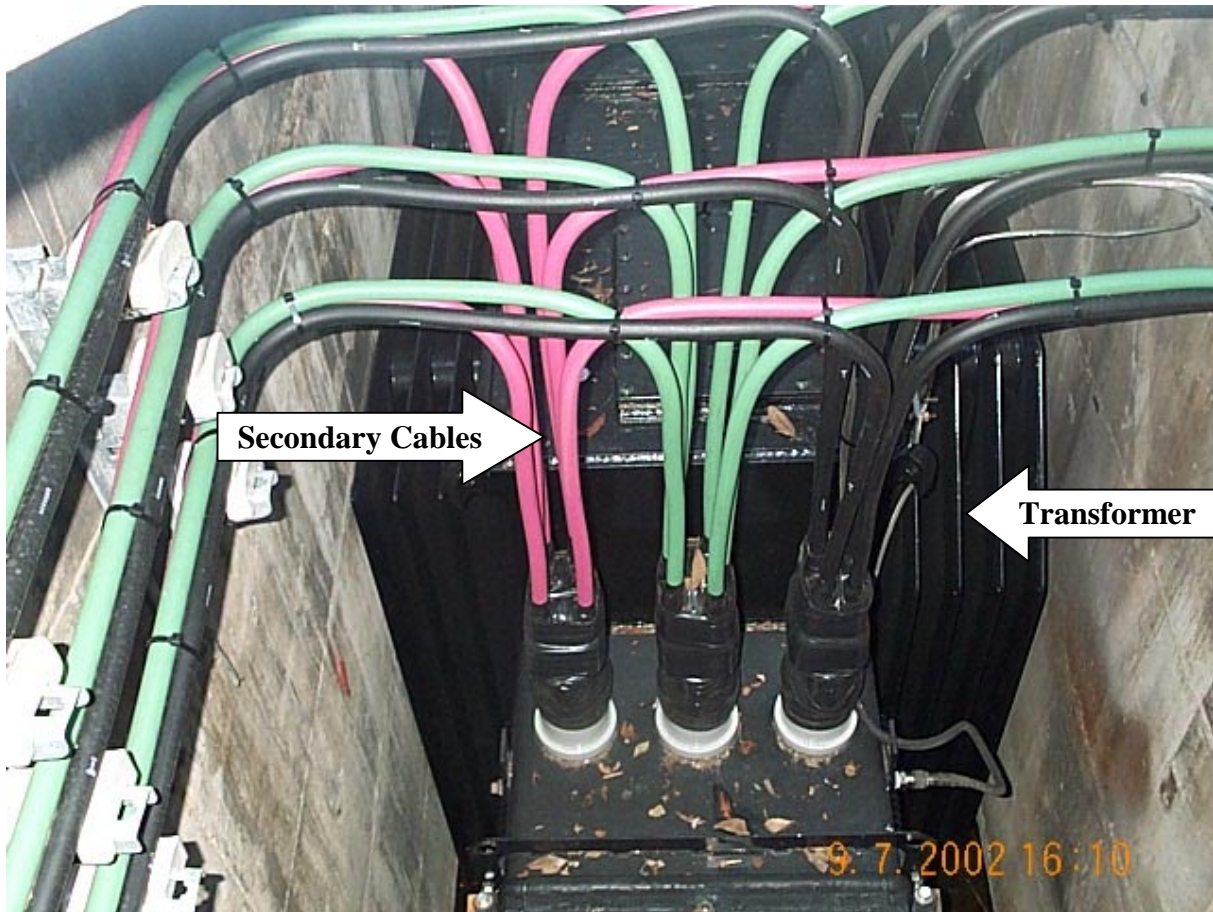
Figure 19 New Transformer Vault with Neatly Arranged Secondary Cables

An example of a well-designed new transformer vault is given in Figure 19. Note the ample space and clean layout.

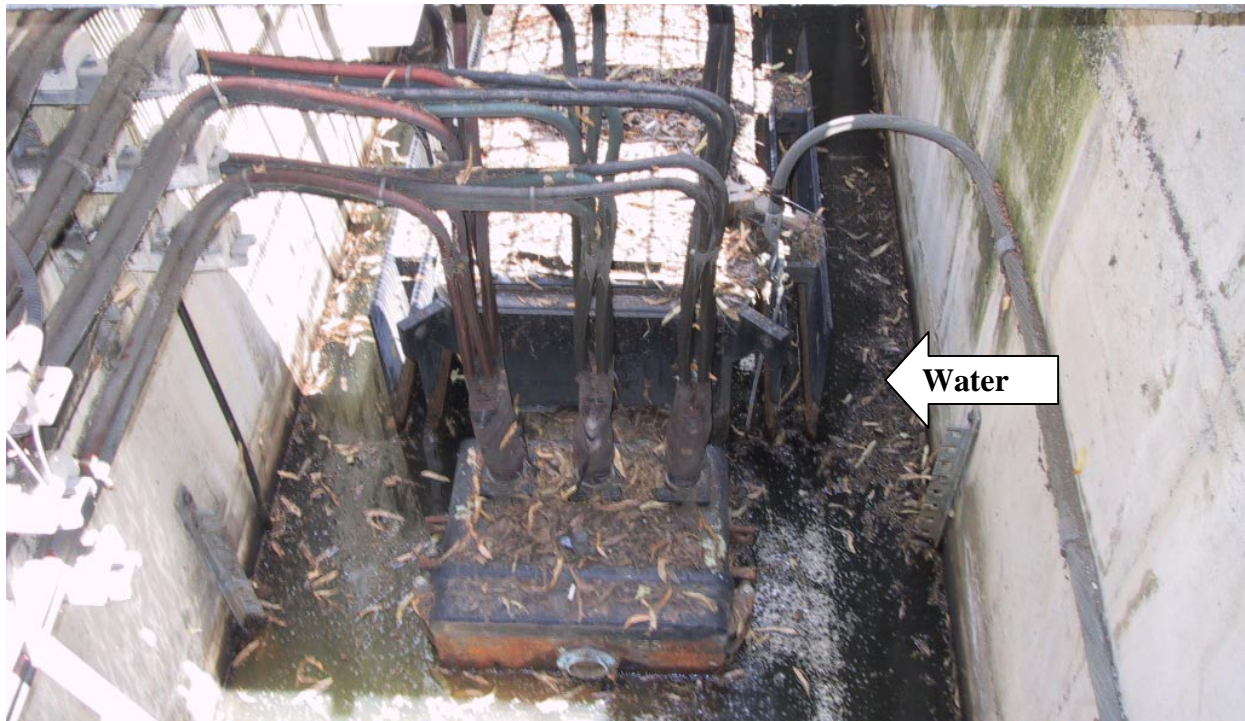
Figure 20 Flooded Transformer Vault with Debris

Transformer vaults are covered with a grating for ventilation. These gratings allow entrance of water and debris (leaves, etc.) as shown in Figure 20, which shows a flooded transformer vault with a layer of leaves on top of the installed equipment. Water is almost up to the top of the protector. Flooded transformer vaults result in rusting of the transformer tank. Some transformers at the Benning Service Center that had been removed from service showed severe rusting on the lower part of their tanks due to water immersion.

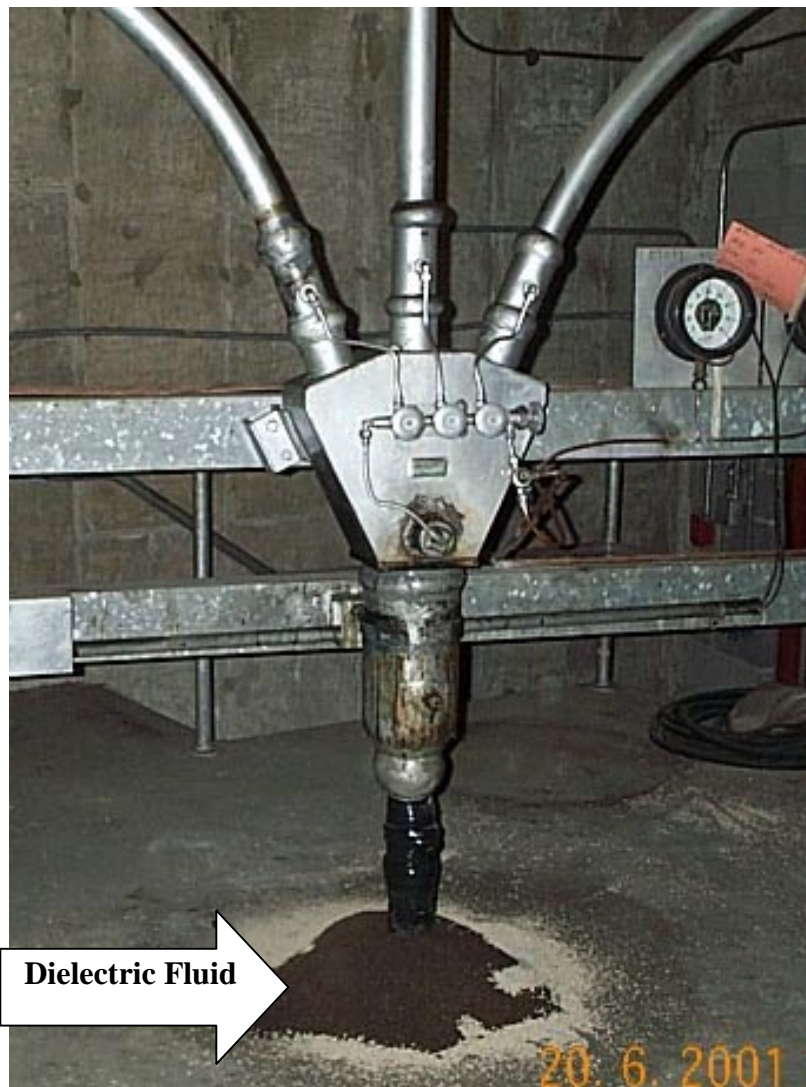
Figure 21 69 kV Transmission Cable Leaking Dielectric Fluid

At one substation it was noted that a 69 kV transmission cable termination was leaking dielectric fluid. Figure 21 shows dielectric fluid being collected by an absorbent material. It should be noted that, based on Pepco's design criteria, the failure of a single transmission feeder will not result in customer outages.

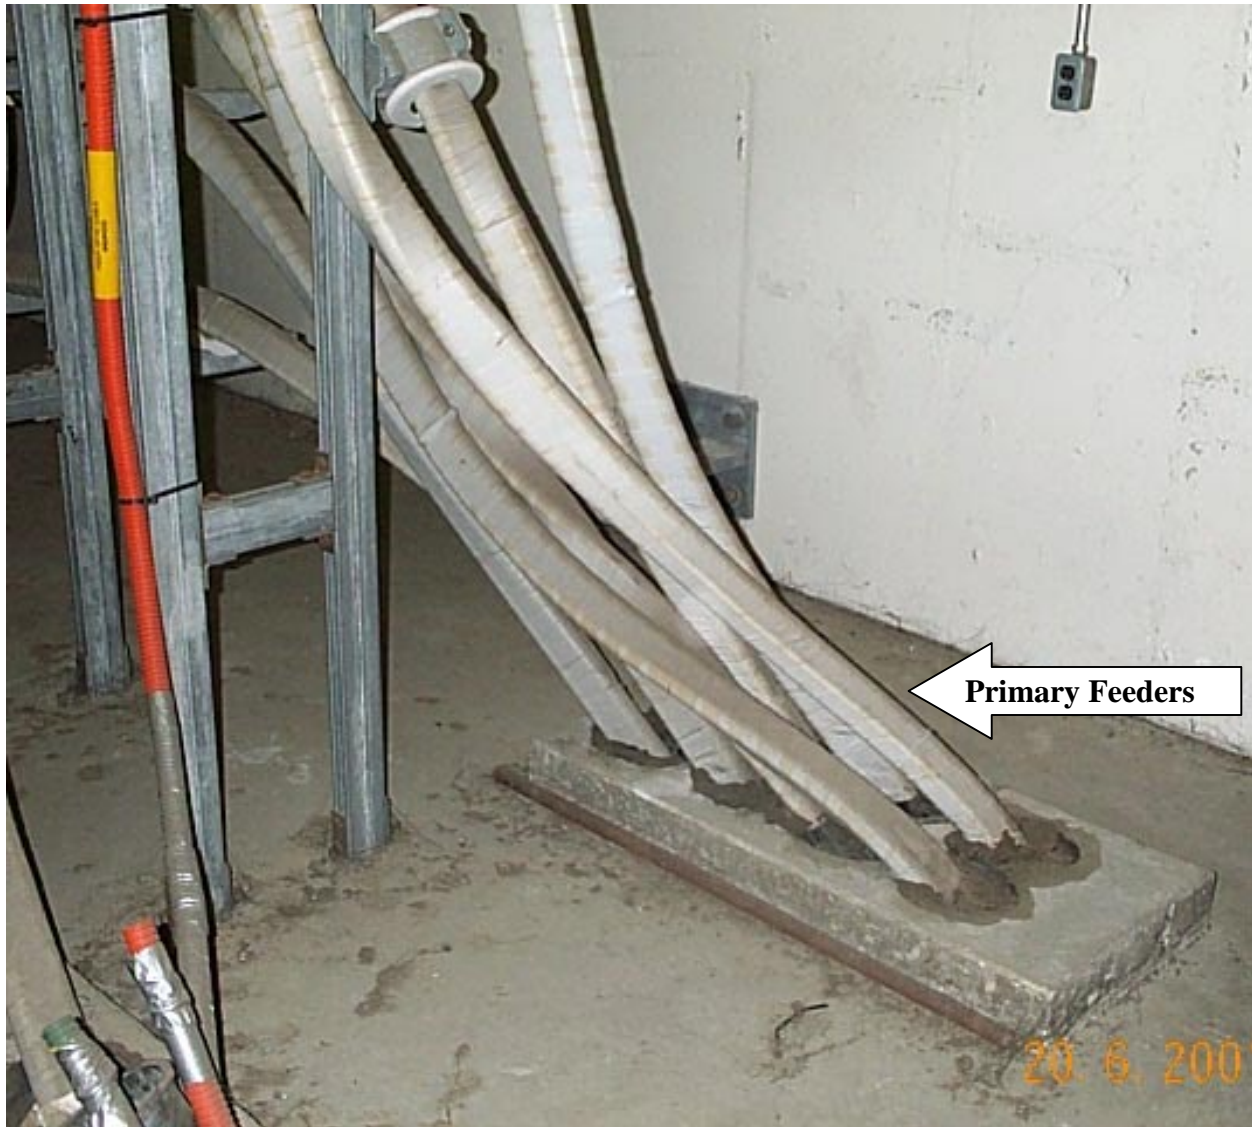
Figure 22 Primary Feeders in Substation Showing Good Workmanship

The primary feeders at the substations generally show good workmanship (Figure 22). However, problems do occur, such as the leaking primary feeder splice shown in Figure 23, as noted by fluid spots on the lower cables and floor.

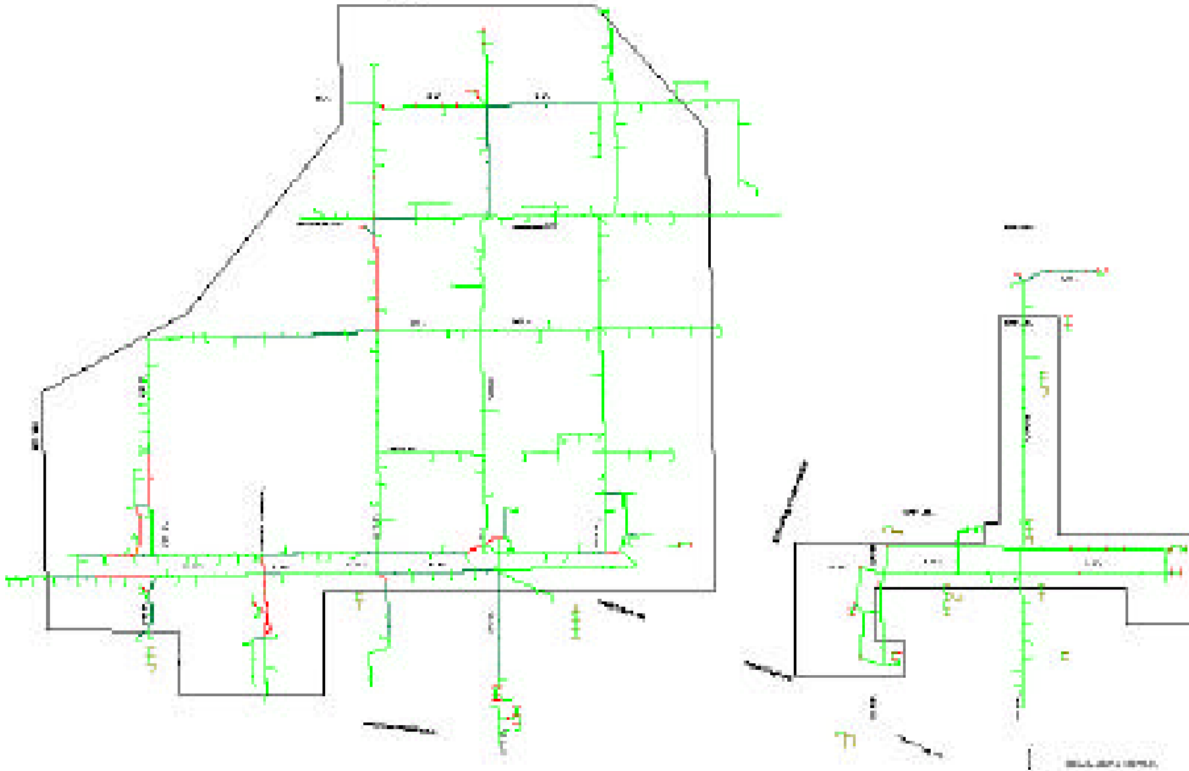
Figure 24 Georgetown East Network Load Flow Results from ABB Report

Figure 24 was taken from the “Georgetown Area Network System Evaluation” report.
