**Assessment of the Underground Distribution System
of the Potomac Electric Power Company**

Final Report

Investigation into Explosions Occurring in or Around the Underground
Distribution System of the Potomac Electric Power Company

Prepared by Stone & Webster Consultants
For the Public Service Commission of the District of Columbia

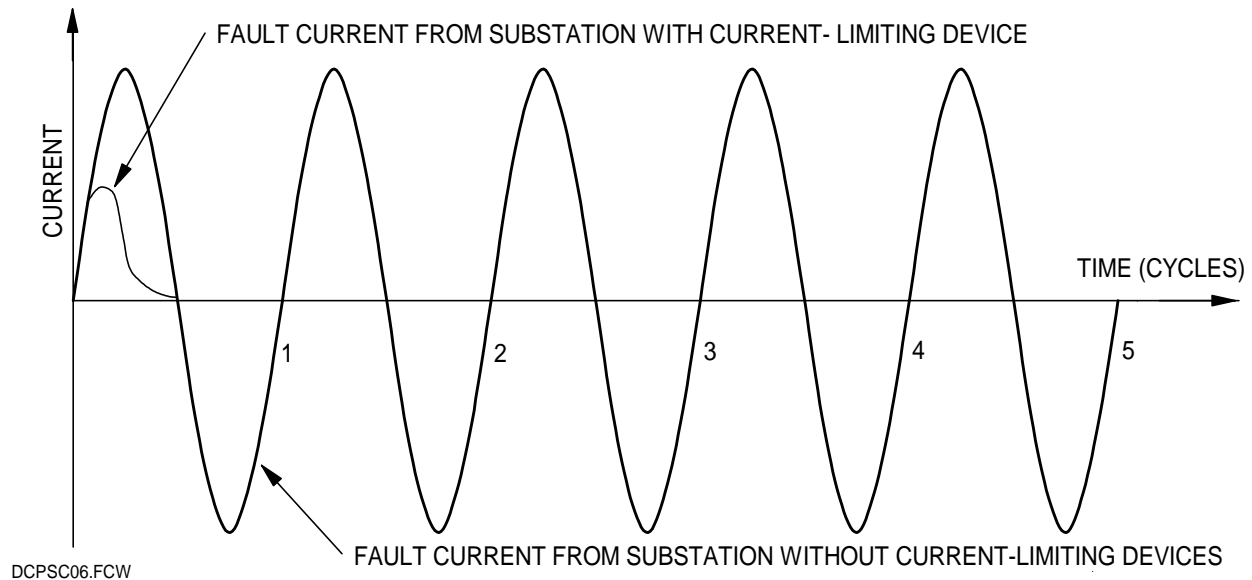
Figure 25 Comparison of Waveform of Fault Current from Substation with and without a Current-Limiting Device at the Station

from the high-current arc. Reducing energy input will reduce pressures, but studies have not been conducted to quantify the relationship. This is one area that EPRI or other industry groups should consider investigating if indeed a significant percentage of the manhole lid ejections are due to the energy from the effects of the high-current fault arcs in primary cable splices.

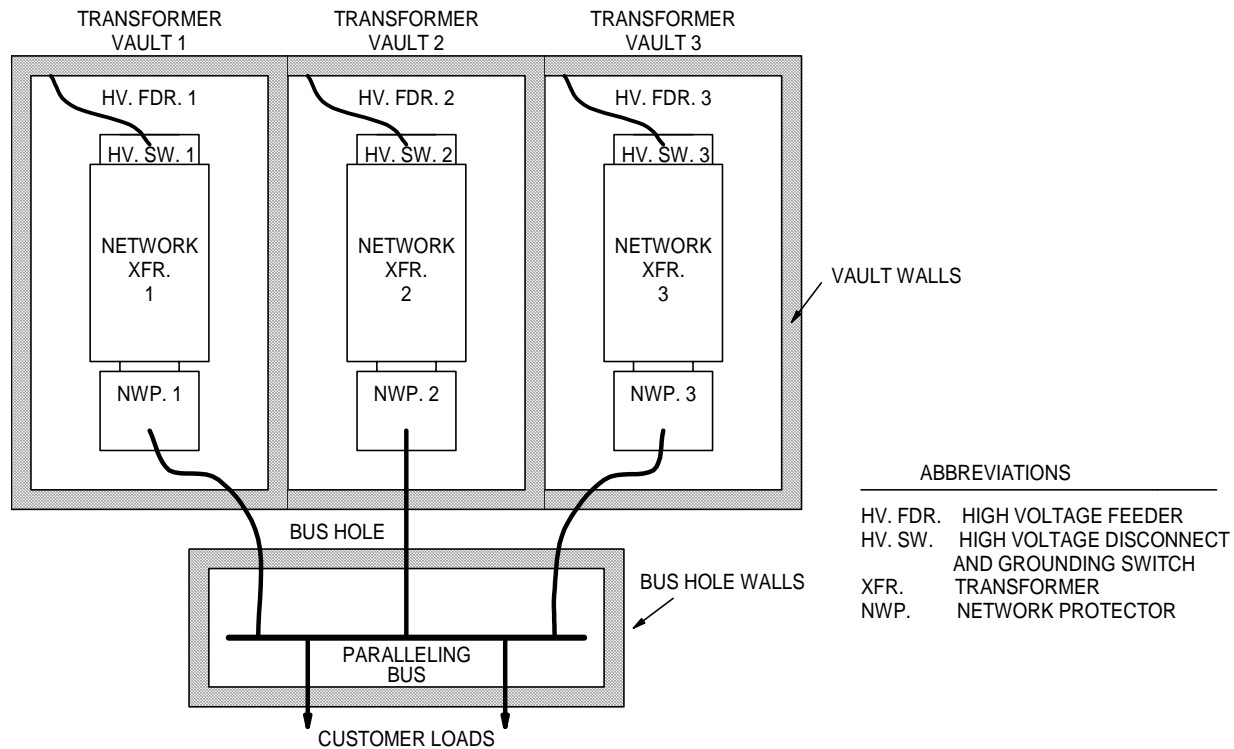
Figure A.3-1 Three-unit Spot Network Where Each Network Unit and the Paralleling Bus Are In Separate Vaults

In contrast, some utilities will locate all of the network units and the paralleling bus in the same vault, exposing multiple primary feeders and unfaulted equipment to the effects of a disruptive failure of liquid filled apparatus.

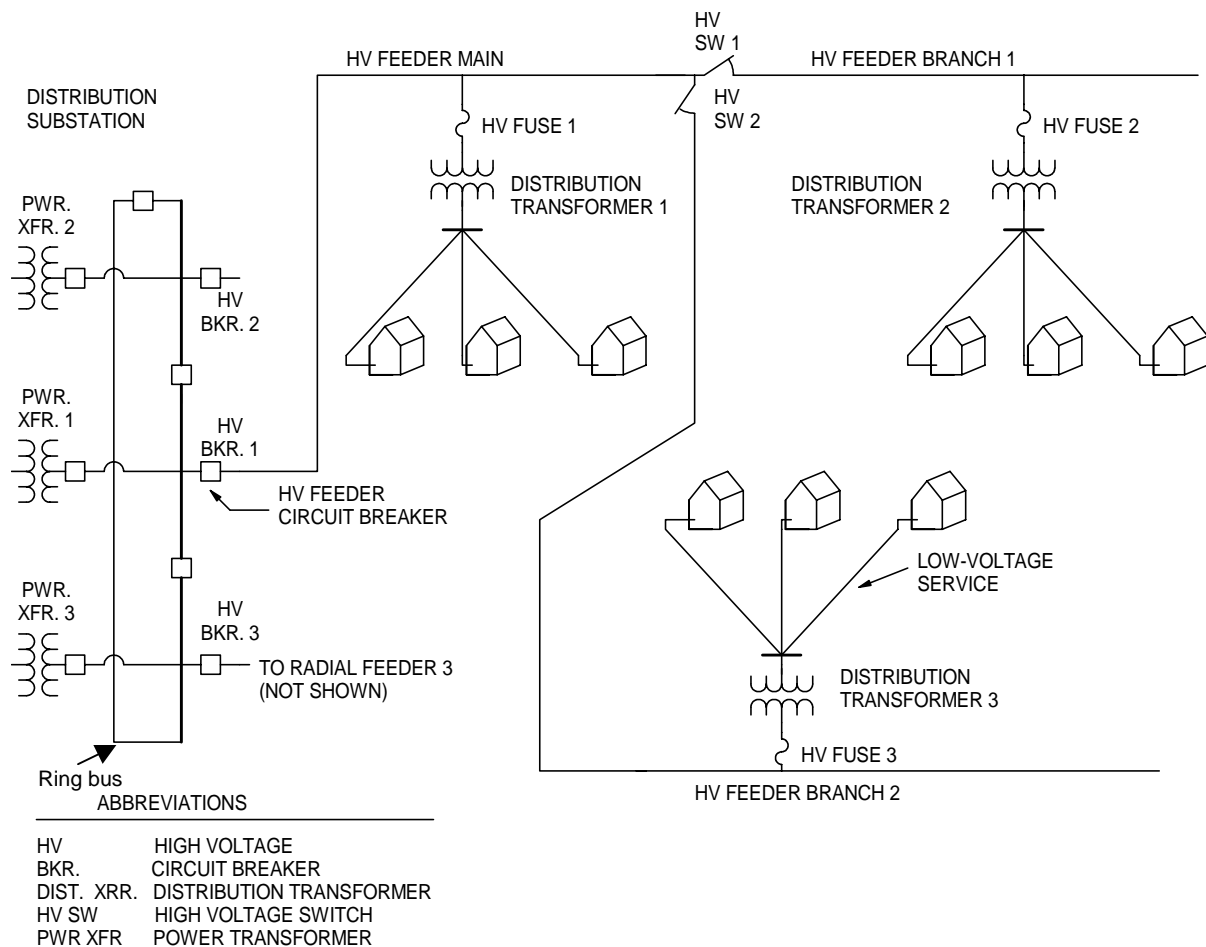
Figure A.3-2 Simplified Radial Primary Distribution System

Radial systems have a simpler configuration and lower cost than low-voltage network systems. Low-voltage network systems are used mainly in commercial areas and other areas where it is desired to supply the highest level of reliability that is possible with conventional types of power systems. Figure A.3-2 shows a simplified radial primary distribution system.

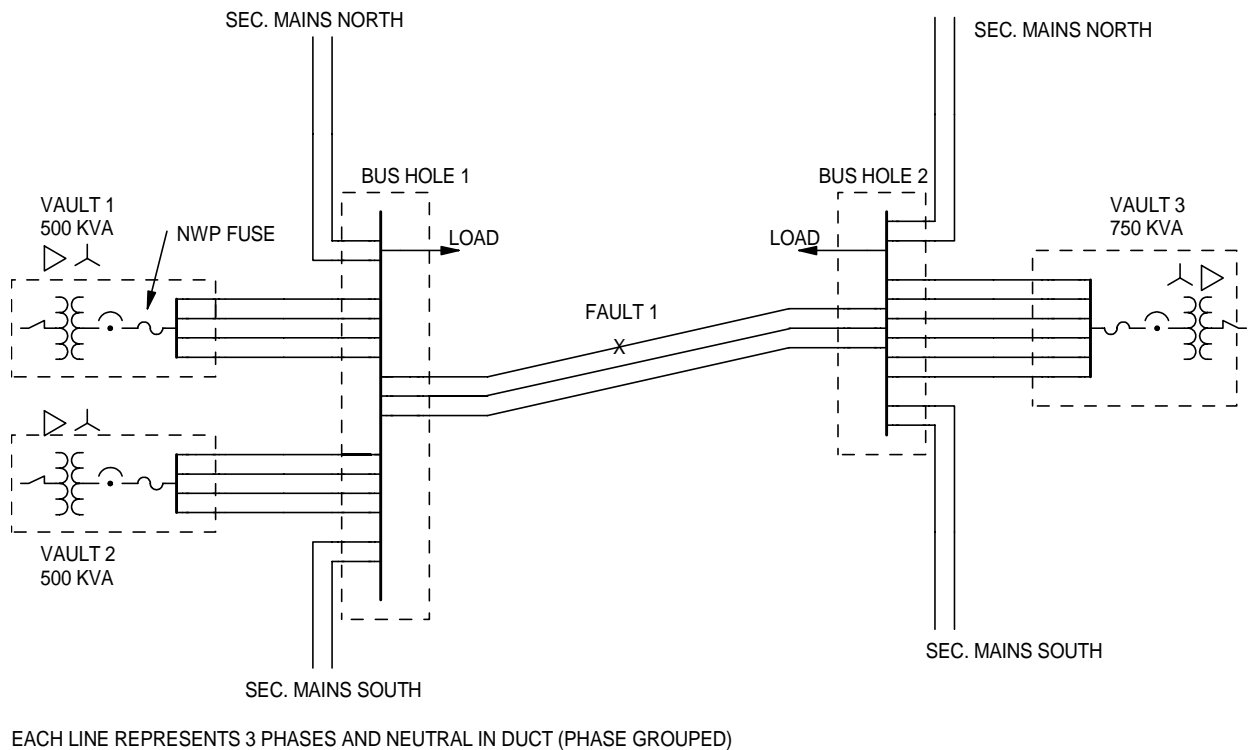
Figure A.3-4 A Portion of a Low-Voltage Network System without Cable Limiters

Cable limiters were not used in the early low-voltage secondary network systems, and today some utilities still do not use cable limiters. Figure A.3-4 shows a portion of a low-voltage network system where cable limiters are not used. In comparison, some utilities install cable limiters on all secondary cables, including 250 kcmil copper cables as used by Pepco, irrespective of the available fault current and the number of sets of cable in a duct. In the Pepco 208-volt secondary systems, cable limiters are installed in some 208-volt secondary circuits. In Pepco’s 480-volt secondary system, cable limiters are installed in all low-voltage cable circuits, irrespective of cable size or available fault current.

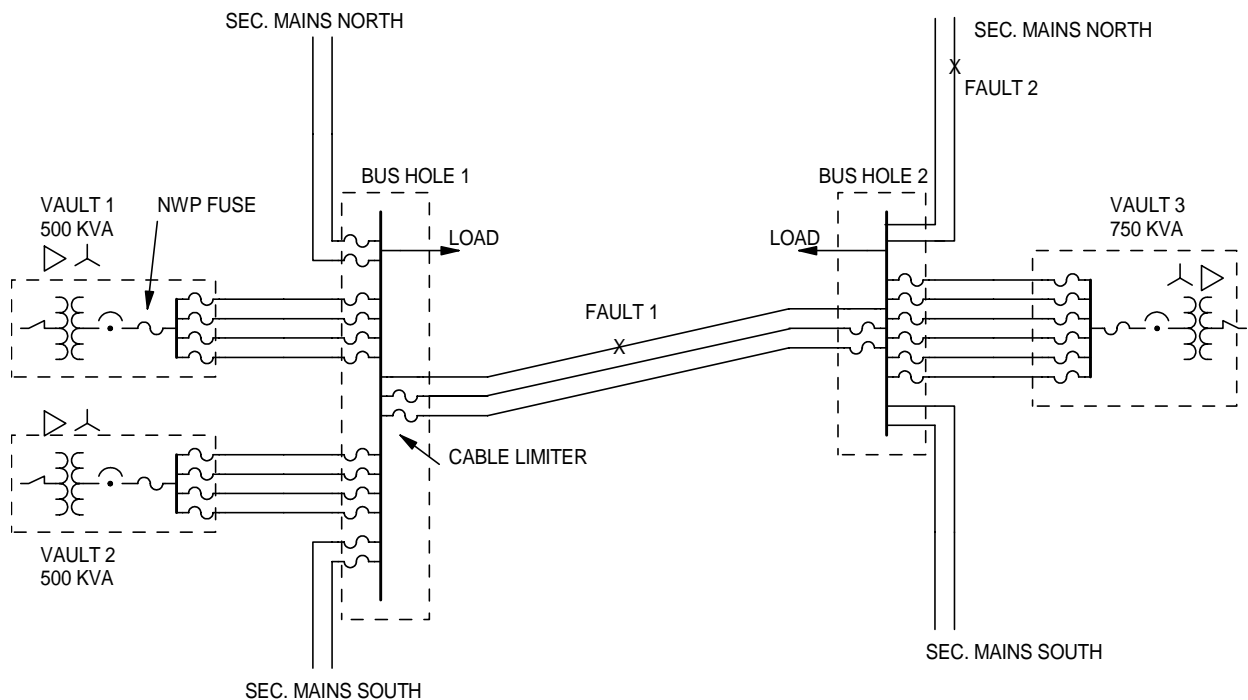
ABB has recommended that Pepco consider evaluating if limiters should be installed in all 250 kcmil cable circuits, irrespective of the available fault current levels.

EACH LINE REPRESENTS 3 PHASES AND NEUTRAL IN DUCT (PHASE GROUPED)

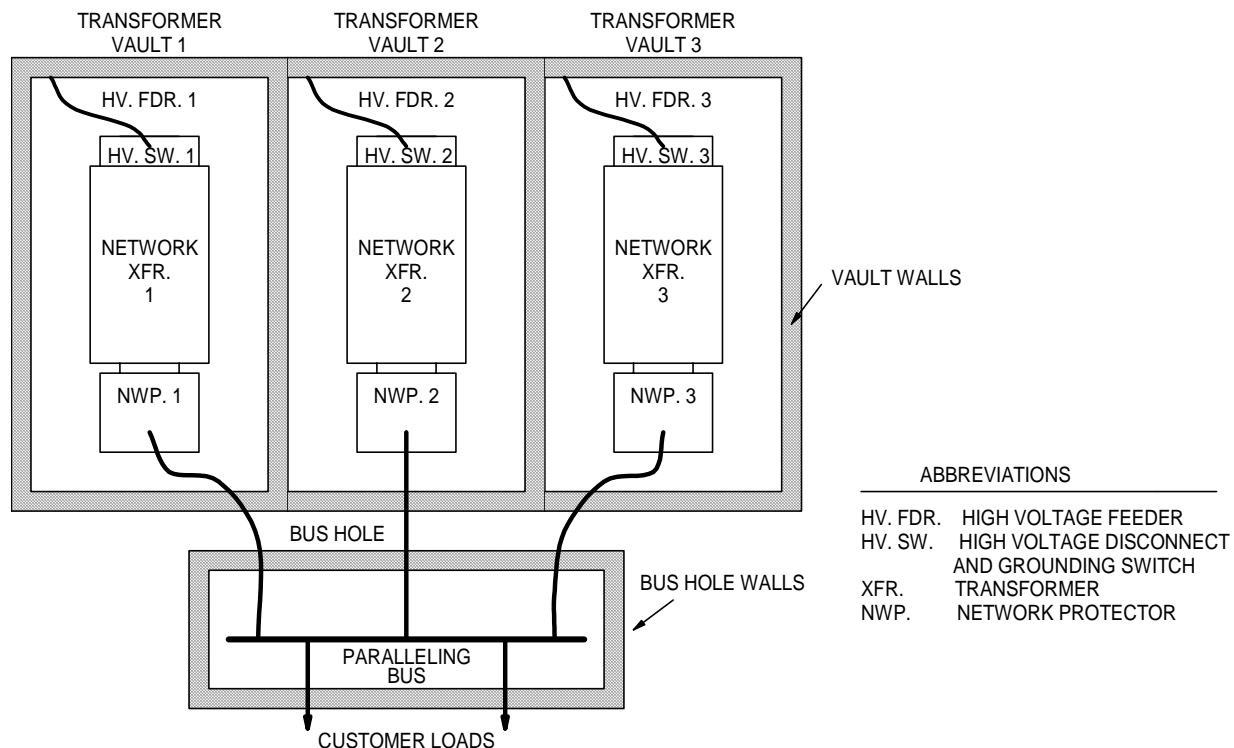
Figure A.3-8 Three unit Isolated Spot Network System

Pepco operates isolated spot networks in the DC area. An isolated spot network consists of two or more network units installed at the same location. A network unit consists of a network transformer and a network protector. The load terminals of the network protectors are connected to the paralleling bus located in the bus hole, adjacent to the vaults with the network units. Customer loads are fed from service cables connected to the paralleling bus in the bus hole, as shown in Figure A.3-8. In the isolated spot network system, there are no ties to the low-voltage secondary mains located in the streets.

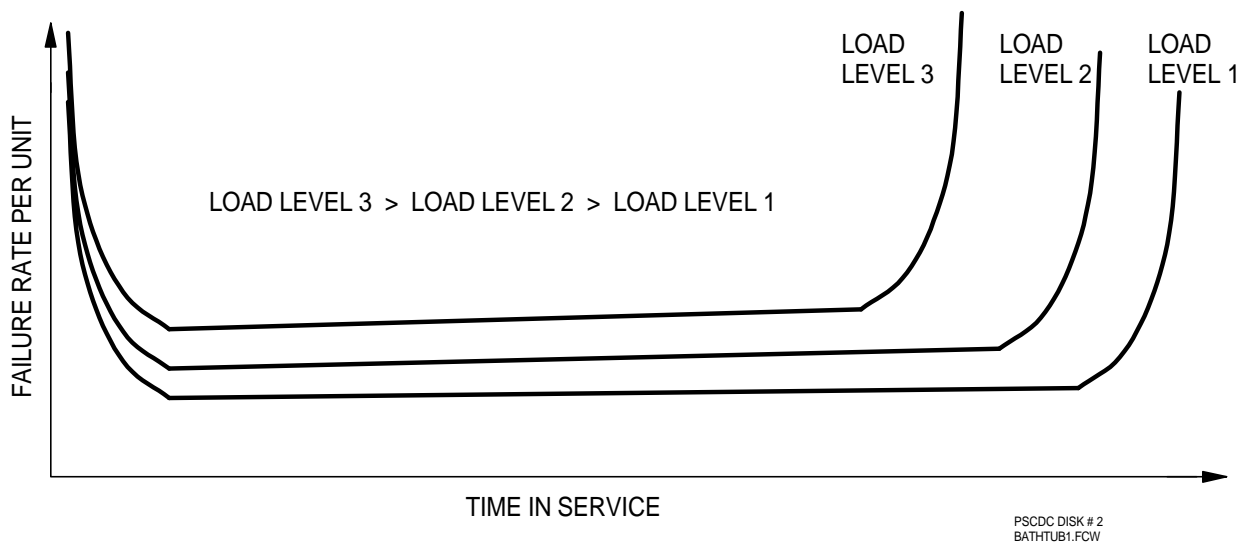
Figure B.1-1 Bathtub Failure Curves for System Components

We don’t argue the validity of the typical bathtub failure curve (shown below) that might apply to cables, transformers, and perhaps splices. However, we question the **significance of age solely** on failure rates for cables, splices, and transformers, and at what point in time the curves start to turn up steeply. A more important measure of when to change out a cable, transformer, or a piece of equipment is the failure rate or performance. Figure B.1-1 illustrates how loading might affect the life of an underground distribution system.
